## Inspection Report Minerals Regulatory Program Report Date May 30, 2006

Mine Name: Ziegler Gilsonite

Operator Name: Ziegler Chemical and Mineral

M0470013, Ziegler Gilsonite Mine, Ziegler Chemical and Mineral

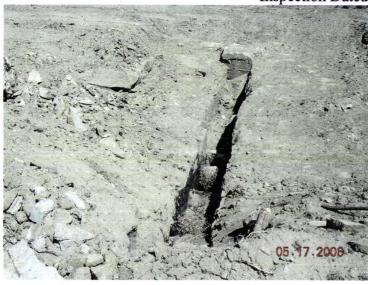
We visited two partially reclaimed sites, Cowboy and Cowboy 2, and one inactive site on the North Vein. At Cowboy (Photos 1-3), the operator intends to take the building (Photo 2) to the Neal State Mine to use as a hoist house. There are other items that also need to be cleaned up. There are two concrete slabs at Cowboy 2 (Photo 5) that the operator plans to use to cover the shaft at Cowboy. Once the slabs are in place, the operator will pour concrete over the top to create a cap with a total thickness of, as I understood it, two feet. Before pouring the concrete, it will be necessary to anchor rebar into the existing slabs so the new concrete will have something to which it can bind. Half-inch rebar will be put in the new concrete at one-foot intervals. The operator will try to have this work completed by September 1, 2006.

Photo 1. The shaft at the Cowboy Mine.

The Cowboy Mine should be seeded this fall as soon as possible after grading is completed. The surface should be left very rough.

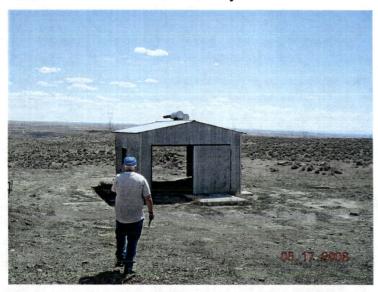
Photo 2. The operator intends to use this building as a hoist house at the Neal State Mine.

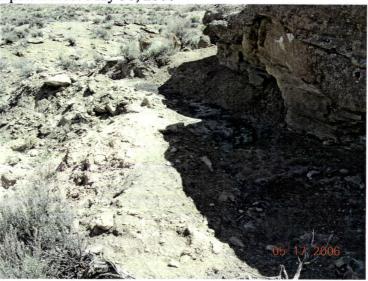
There is a small drainage leading to the reclaimed escapeway for the Cowboy Mine, and the operator has modified this drainage so runoff is diverted away from the escapeway.

Photo 3. Diversion near the escapeway at the Cowboy Mine.

The drainage in the area of the Cowboy escapeway needs to be armored so it can be more permanent.

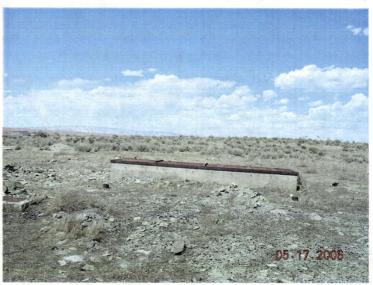
Cowboy 2 (Photos 4-6) is mostly reclaimed, but the operator needs to install the cap. This needs to be done so it can be buried.

Photo 4. This is the collar over the shaft at he Cowboy #2 Mine.

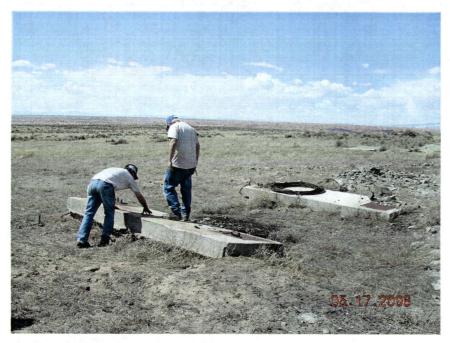
Photo 5. The operator intends to use these slabs to cover the shaft at the Cowboy Mine.

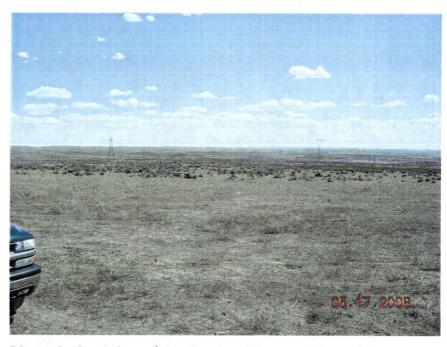
Most vegetation at the Cowboy 2 site is cheatgrass, but there are some perennials, notably purple three awn and gooseberryleaf globemallow. There is also some galleta and Wyoming big sage in the area.

Photo 6. Overview of the Cowboy #2 area. Most of the vegetation is cheatgrass.

At the Cowboy 2 Mine, I recommend that the operator consider remedial work to reduce the amount of cheatgrass and increase the perennials. If this is not done, I believe it is unlikely the area will have enough perennial vegetation cover within the foreseeable future to allow for complete release. The operator should consider application of an herbicide called Plateau. The Division has further information about this herbicide. It would be necessary to obtain approval from the BLM to apply the herbicide, but it should be possible since the site is less than five acres.
